INCIDENT INVESTIGATION REPORT

Fuel Tank Product Release ◀

**TapRoot® Investigation – Rubis Cayman Islands Limited, Jackson Point Terminal Fuel Release
from Tank No. 32198**

Grand Cayman, Cayman Islands

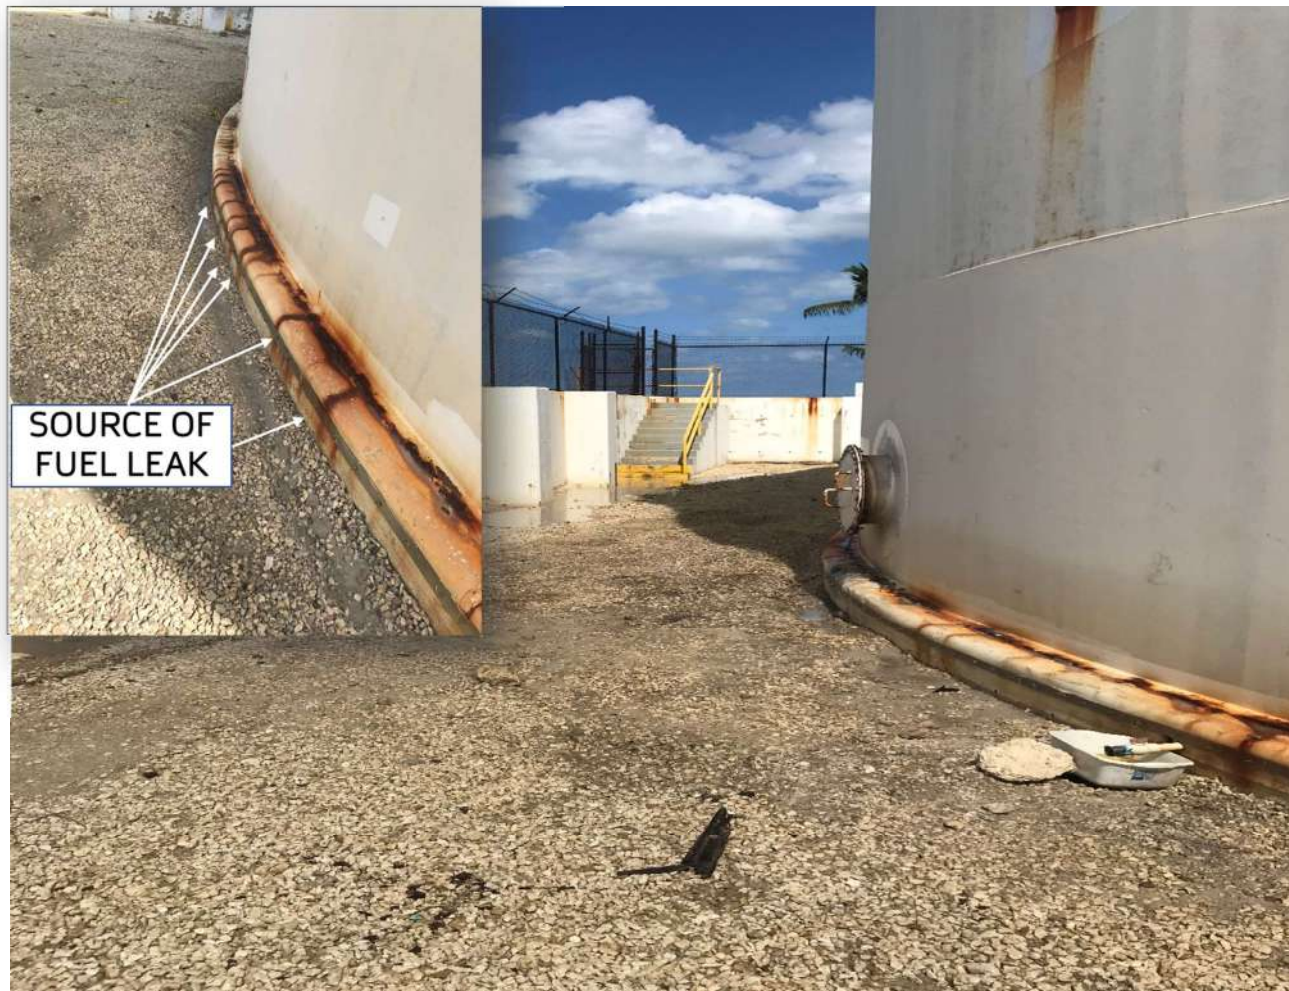
13. Source of Leak

A physical inspection of Tank #32198 performed by the investigation team indicated the fuel leak was a result in the failure caused by severe rusting in several areas of several tank bottom plates in the Tank. The leak resulted in a spill/environmental release of fuel to the ground in and around the tank and adjacent area on the western side of the tank.

Photo: Western side of Tank # 32198

Inset: Source of the Diesel Fuel Leak in Tank # 32198.

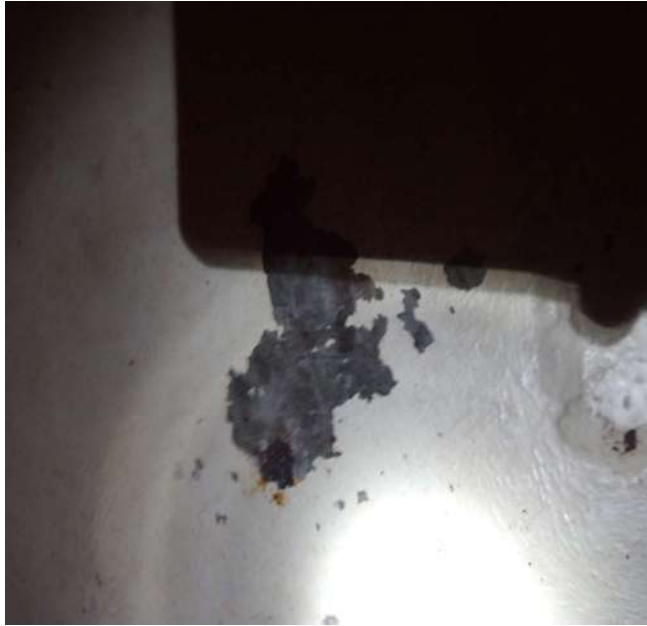
Tank #32198 Bottom Plate Failure

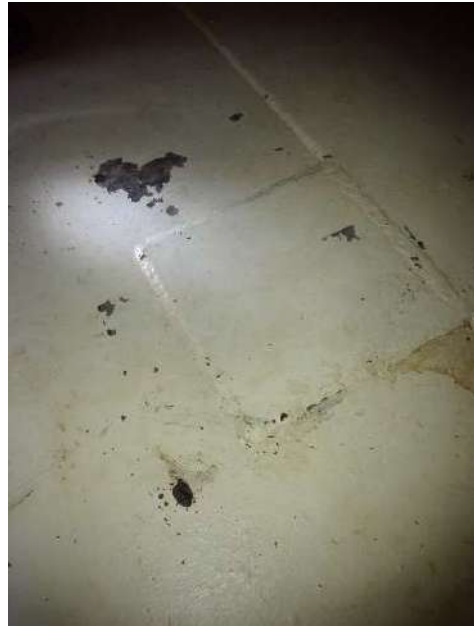
Tank #32198 Bottom Plate Failure

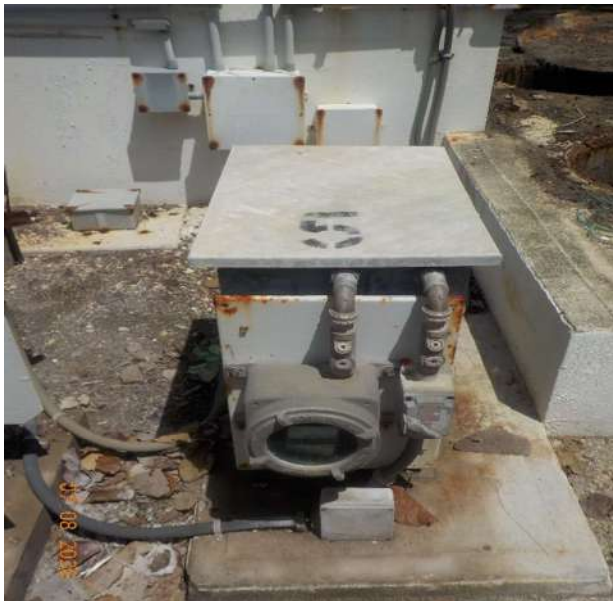
During the Cathodic Protection Annual Survey completed in 2014 by third-party contractor Southern Cathodic Protection Company, the Rectifier for Tank #32198 was found off. It is noted in the Cathodic Protection Annual Survey submitted by Southern Cathodic Protection Company that Rectifier's should always be energized to ensure safe operation and corrosion control.

Tank #32198 Rectifier # 5

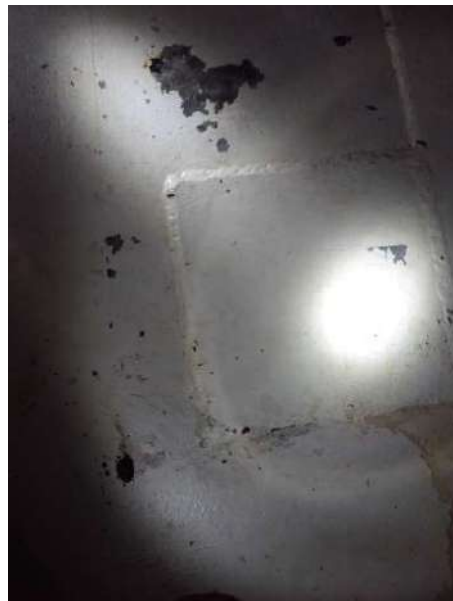
Tank #32198 Bottom Plate Failure

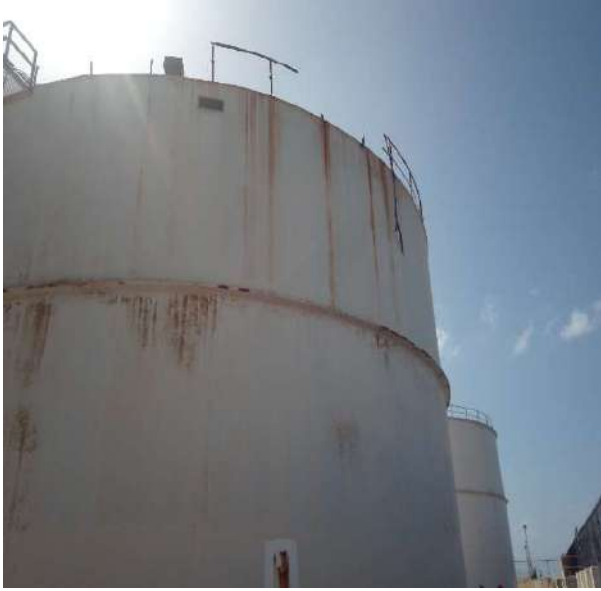
Areas of Rust on External Tank Shell

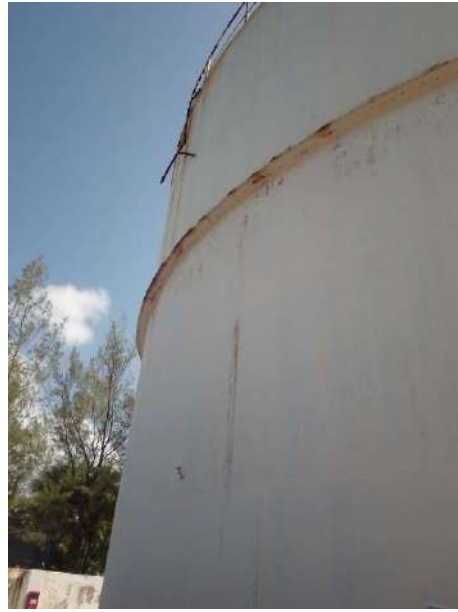
Areas of Rust on External Tank Shell

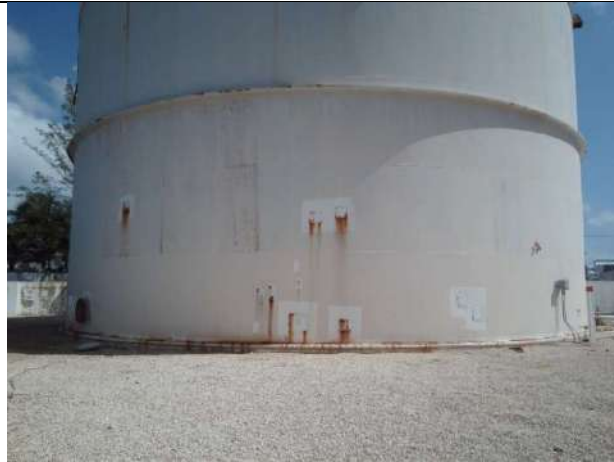
Areas of Rust on External Tank Shell

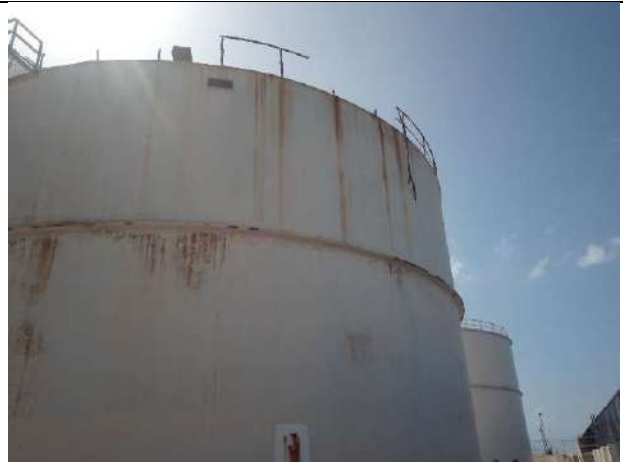
Areas of Rust on External Tank Shell

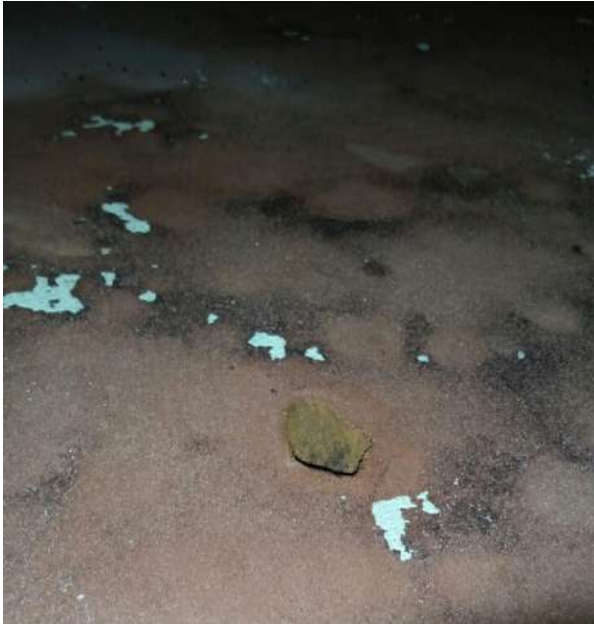
After sandblasting and cleaning of the tank was complete, a hole in the bottom of the tank was discovered. The entire sandblasted surface was hand wiped with mineral spirits and no other defects were found. In fact, the rest of the tank seemed to be in very good condition. At this time API standard for patching a tank, were consulted and plans were made to place a patch over the hole and have a welder install the patch plate.

Figure 1: Hole in Floor

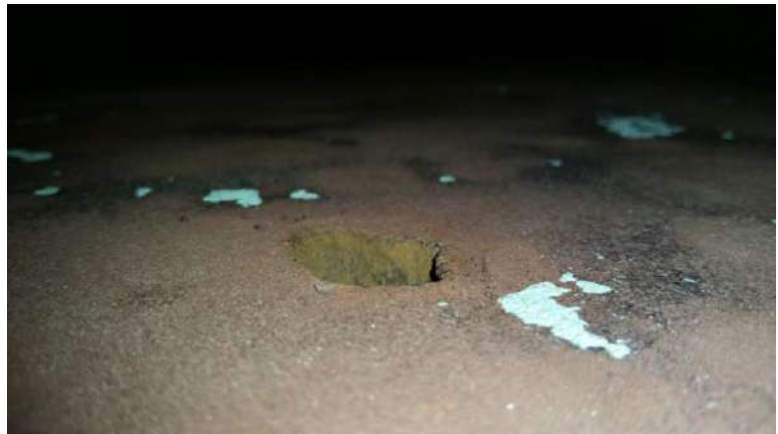
Figure 2: Profile of Hole

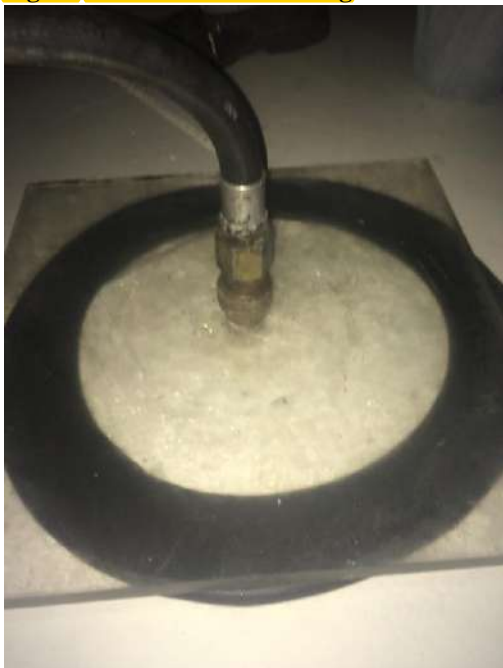
Figure 3: Vacuum Box Testing

Once the floor patch was installed and the bottom and first ring of the tank were repainted a vacuum box test was used to test the welds of the floor patch. Pressure was maintained across the entire patch during the vacuum box testing. The tank was closed and returned to service to receive ULSD product from the incoming tanker.

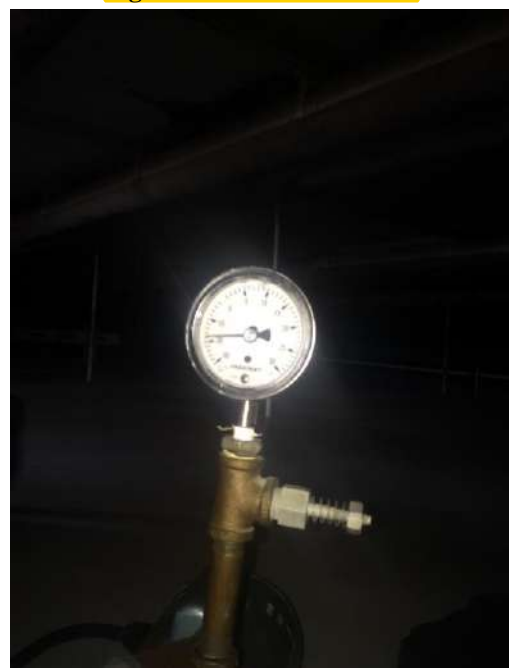
Figure 4: Vacuum Pressure
