Coastal Works Review

**Marriott Beach Resort, Seven Mile Beach Club, South Bay Beach
Club, Plantation Village & Tamarind Bay**

Southern Seven Mile Beach – Shoreline Modification

January 8, 2020

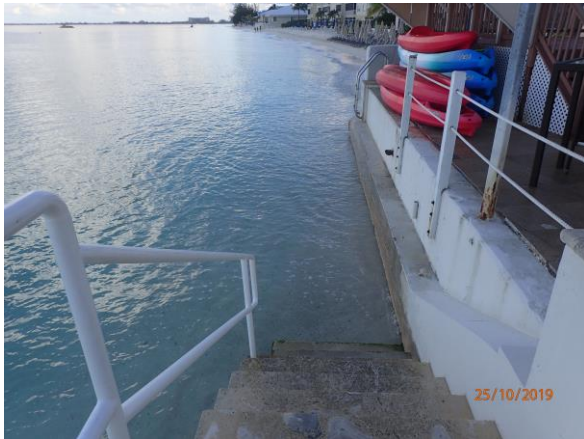
Figure 2: Marriott looking north

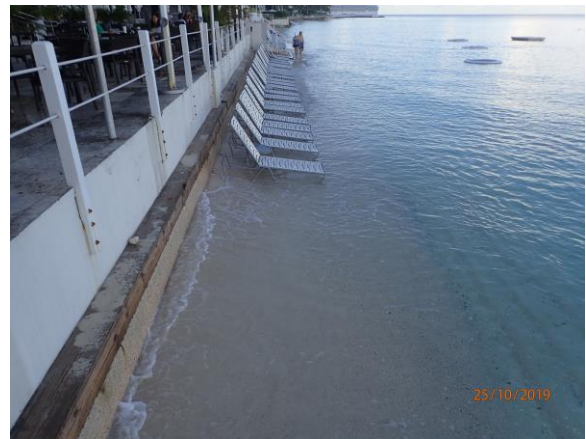
Figure 3: Marriott looking south

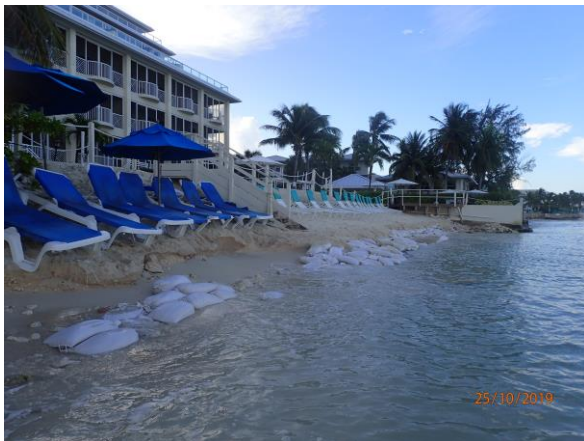
Figure 4: South Bay Beach Club looking south

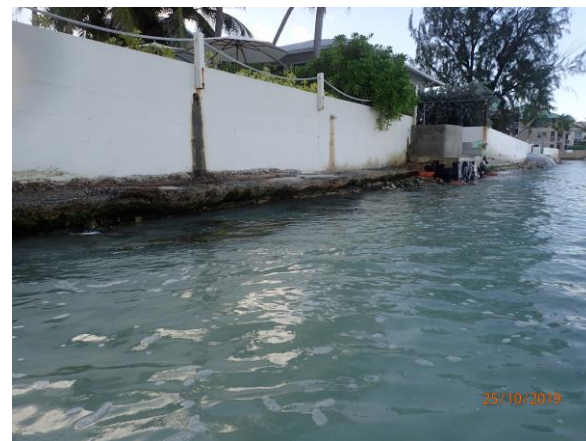
Figure 4: South Bay Beach Club

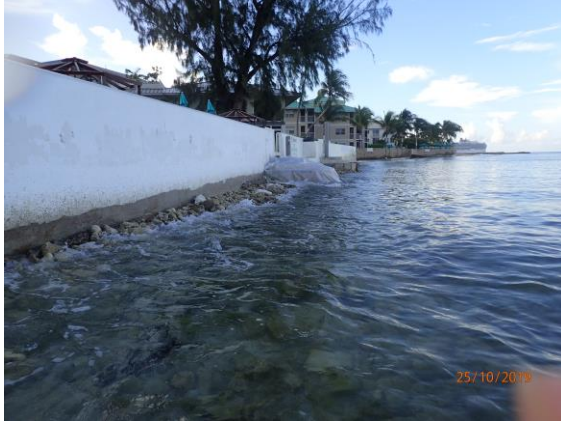
Figure 5: Tamarind Bay

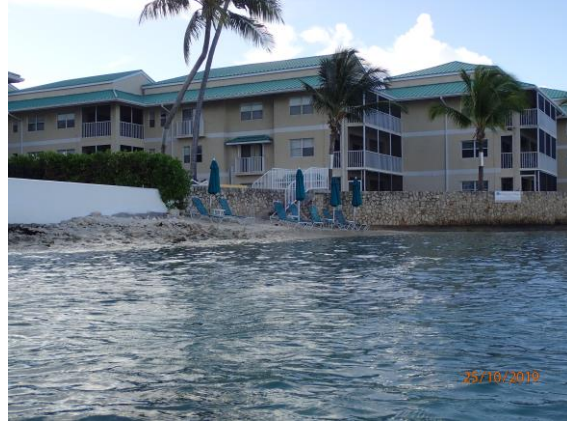
Figure 6: Plantation Village

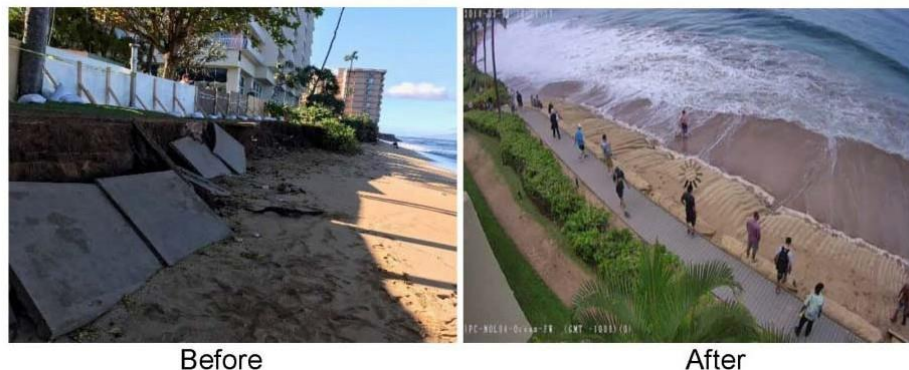
KAANAPALI BEACH CLUB, HI 2018

- The proposed shorefront mattresses can provide undermining/scour protection along the foundation of the seawalls; but they will not promote a sand beach. Instead, their reflective, impermeable surface will retard natural accretion of sand. Upon construction, the mattresses will displace any sand beach that currently exists, and the post-project shorefront (in absence of major renourishment or significant seasonal influx of sand) will be armoured by sand bags, not a sand beach. A visual example of this is shown in the figure below, where shorefront armoring by the proposed Tencate mattresses was constructed along Kaanapali, Hawai'i. The structures protected the oceanfront walkway but do not provide for a practically usable sand beach. It is an armoured beach. Another example includes Waikiki Beach (c. 2017) – where the mattresses arrested erosion, but the beach in this area is more or less cordoned off from use by the public (per my correspondence with colleagues in Hawaii, this date.)

Proposed mattresses deployed along Kaanapali Beach, HI.
