# Benthic Habitat Characterization Survey

## George Town Harbor Berthing Program

August 2015

DOCUMENT NO. CSA-WIM-FL-15-1904-2890-01-REP-01-FIN-REV01

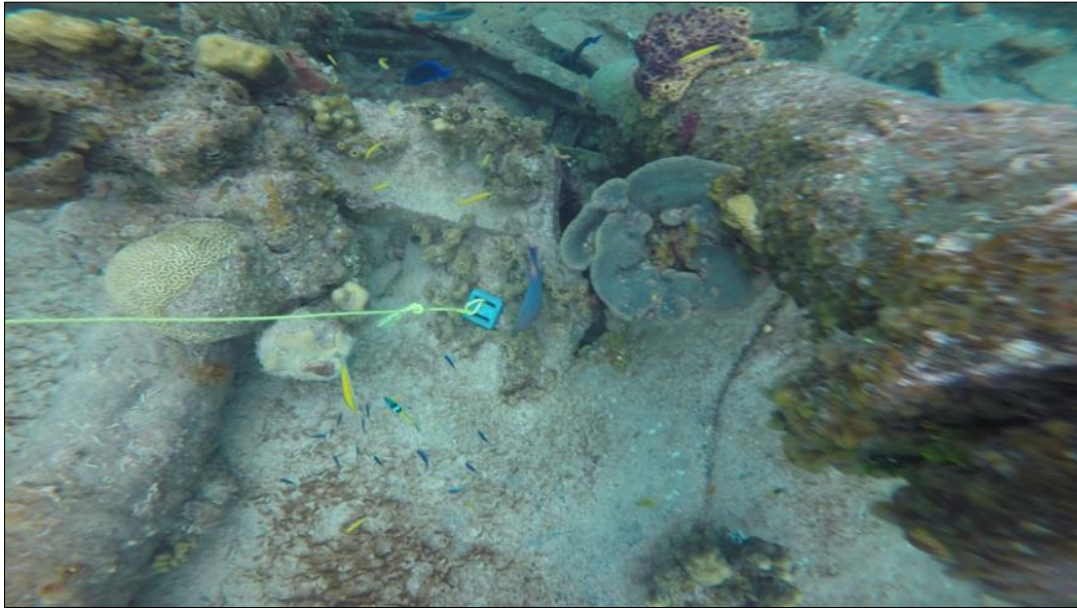
Image 3. One of the 61 bounce dive locations was positioned directly on the *Balboa* wreck and was subsequently classified as a man-made artifact.

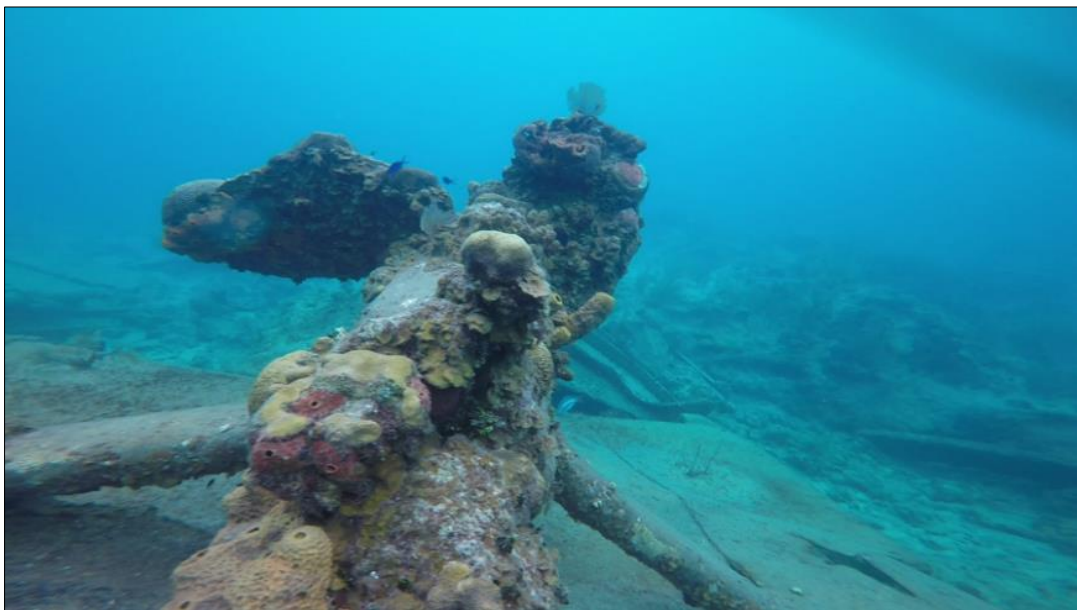
Image 4. Portions of the submerged *Balboa* wreck supported a biological community that included corals.

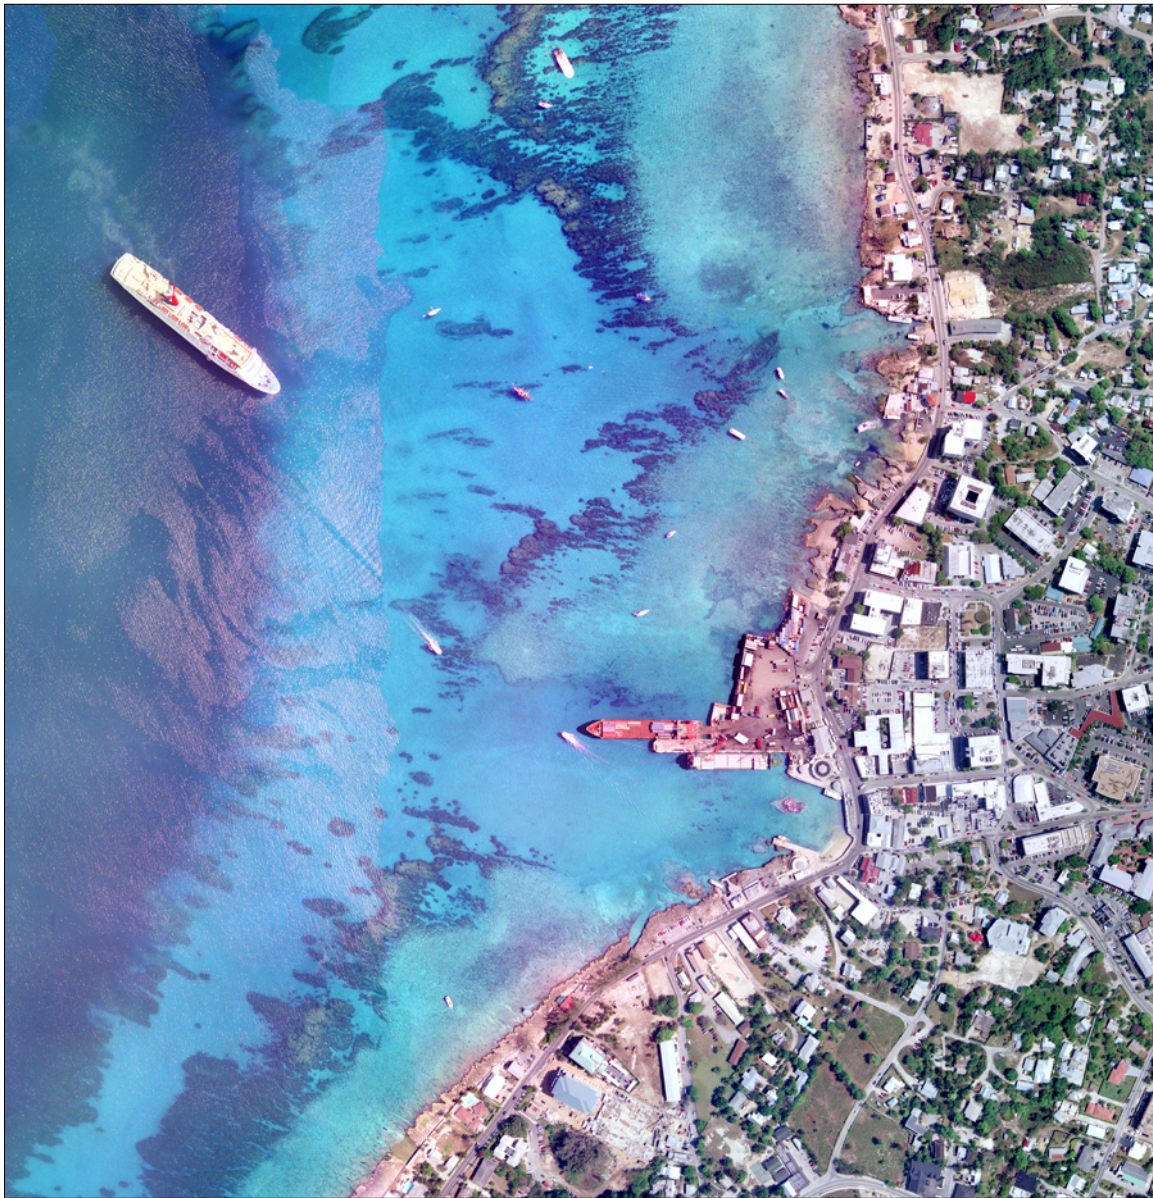
The distribution of the coral supporting habitats as generally delineated in **Figure 3** (i.e., yellow and blue dots) is corroborated by the 1999 aerial image (**Image 5**) of George Town Harbor showing seafloor habitats offshore of the existing dock area. The hard bottom with sand veneer habitat is predominantly along the shoreward portion of the berthing program's projected direct impact area (**Figure 3**). The exposed reef formation habitat is a relatively continuous parallel to shore feature generally distributed along the seaward edges of the hard bottom with sand veneer habitat (**Image 5**).

Image 5. A 1999 aerial image of George Town Harbor showing seafloor habitats offshore of the existing dock area (image was provided by Lands & Survey Department of Cayman Islands Government).

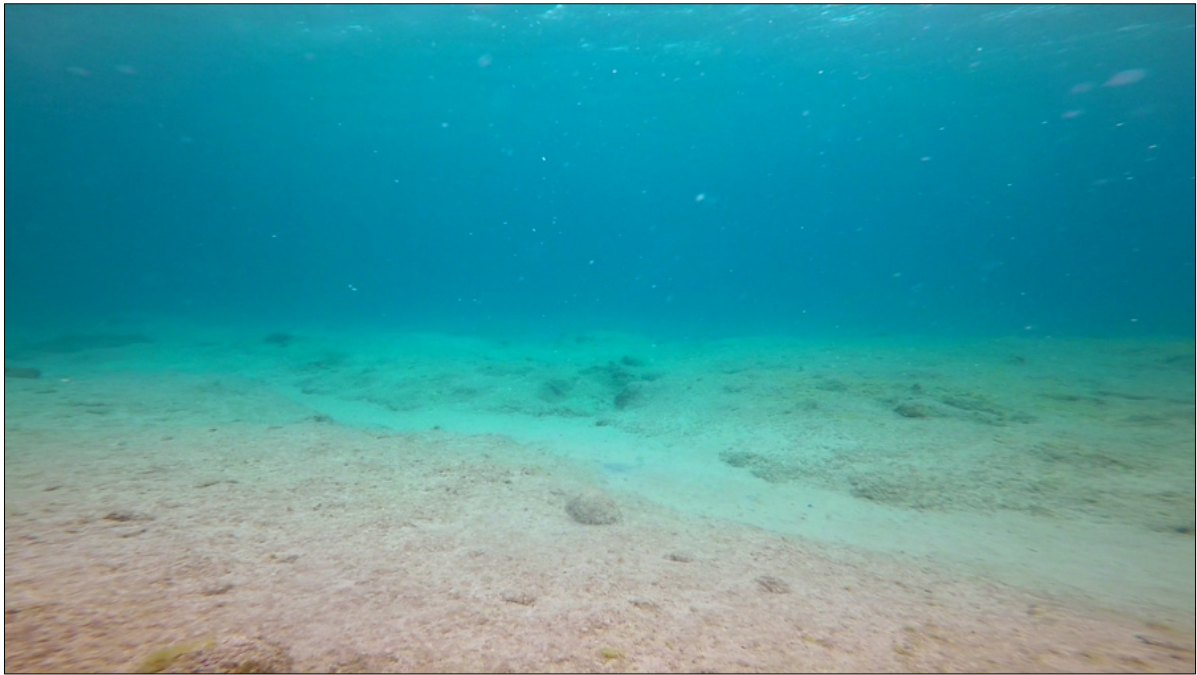
Hard bottom with sand veneer habitat classification was applied to low-relief carbonate substrate which was overlaid by unconsolidated substrate in highly variable amounts (**Image 6**). The variable thickness of the sand veneer and relatively level topography appear to have limited the amount of epibiotic development on this habitat classification (**Image 7**). This habitat had relative distributional continuity along the shoreward central portion of the berthing program's projected direct impact area (**Figure 3**).

Image 6. Hard bottom with sand veneer habitat classification was applied to low-relief carbonate substrate, which was overlaid by a covering of unconsolidated substrate.

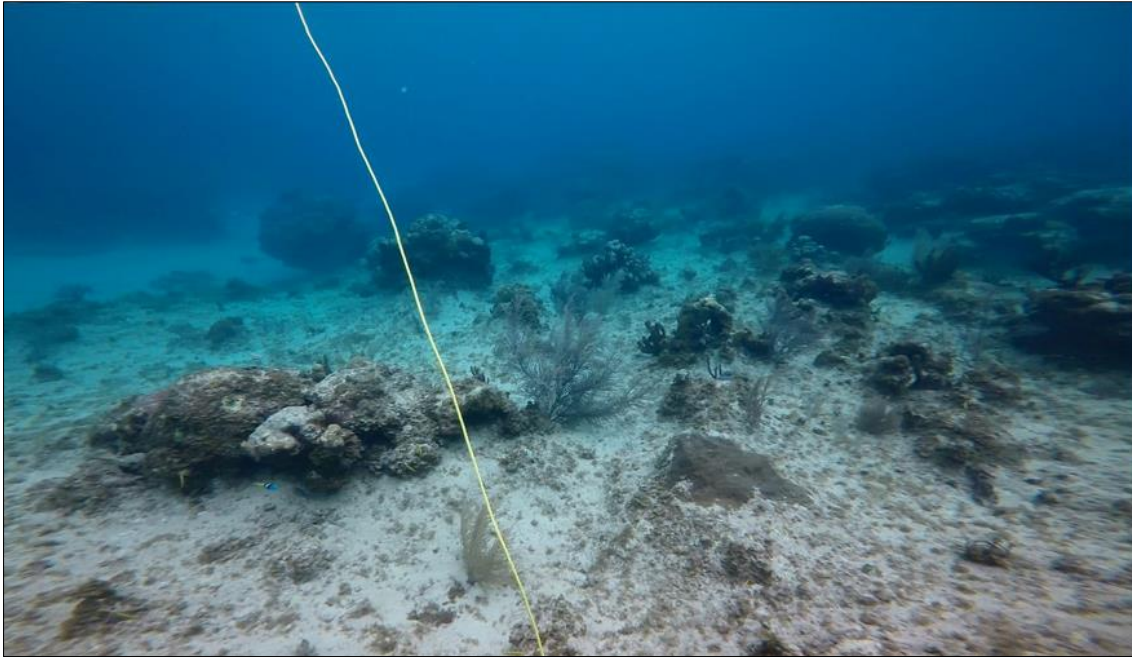
Exposed reef formation classification was applied to irregular relief carbonate substrates that supported a relatively productive epibenthic community with a relative high diversity and abundance of corals. The exposed reef formation habitat is characterized by elevated topographic features, which are primarily a product of hermatypic coral deposition and subsequent disproportional erosion of these deposits (**Image 8**). The irregular topography of the areas classified as exposed reef formation provides elevated substrate and considerable microhabitat (**Image 9**), which visually distinguishes it from the hard bottom with sand veneer habitat.

Image 8. The exposed reef habitat is characterized by elevated topographic features, which are primarily a product of hermatypic coral deposition.

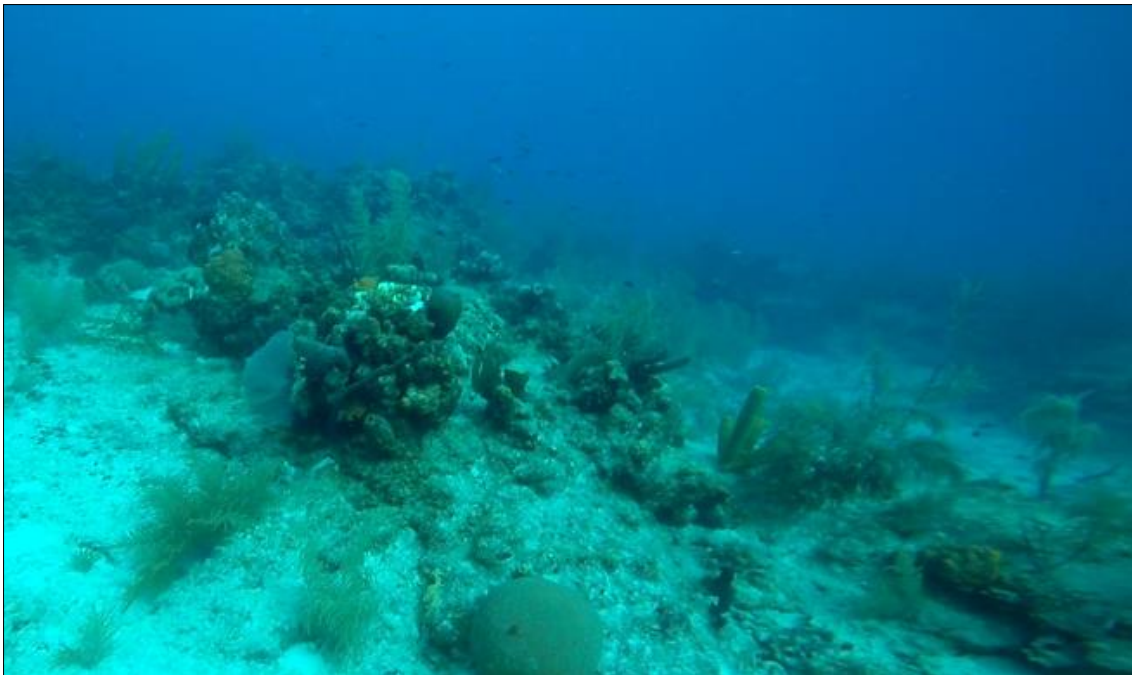
Image 9. Irregular topography observed in the exposed reef formation habitat, which provides elevated substrate and considerable microhabitat.

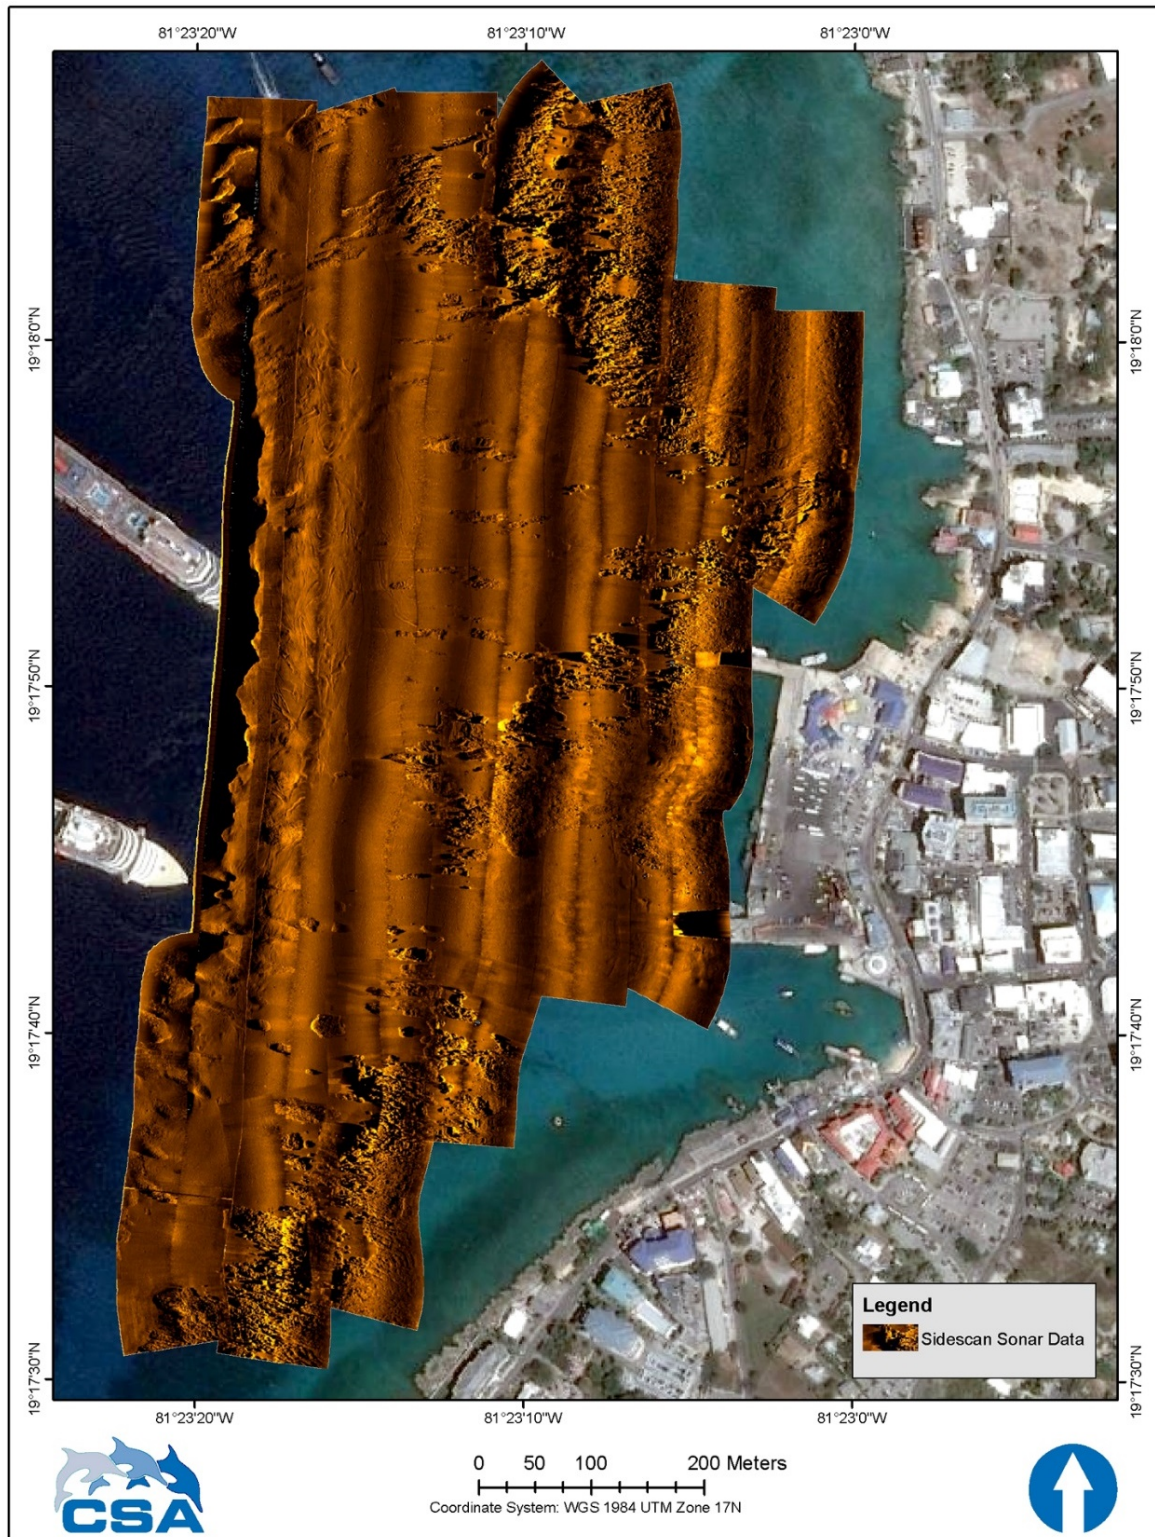
Side-scan sonar data were used to help document and map the distribution of consolidated and unconsolidated substrates within the footprint of the George Town Harbor berthing program (Figure 4).

Figure 4. Mosaic of side-scan sonar data used to help document and map the distribution of consolidated and unconsolidated substrates within George Town Harbor.

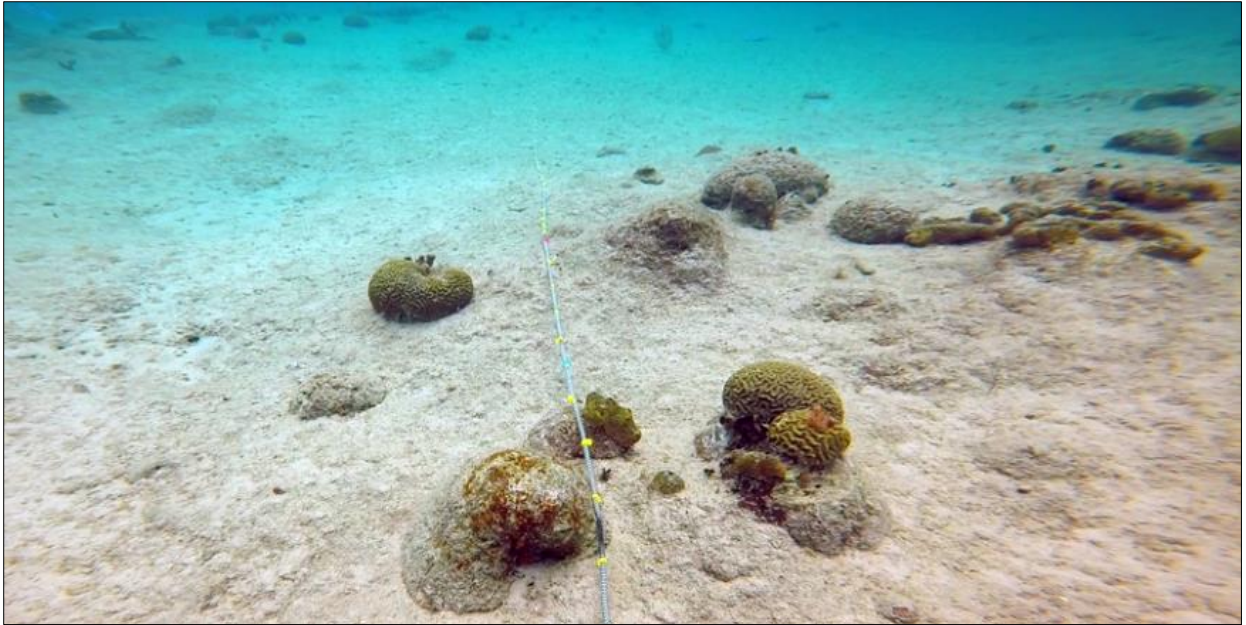
Hard bottom with sand veneer habitat (shown with blue dots in **Figure 6**) was generally characterized by relatively level topography and limited epibiotic development (**Image 10**). Coral densities for the hard bottom with sand veneer habitat ranged from less than 1 to 8 colonies m<sup>-2</sup> of hard corals and from 0 to 4.1 colonies m<sup>-2</sup> of soft corals. The hard bottom with sand veneer habitat was dominated by smaller corals with more than 85% of the hard corals measuring less than 10 cm and more than 80% of the soft corals measuring less than 25 cm. The dominance of small corals coupled with low coral density would make coral translocation very laborious in this habitat type.

Image 10. Representative image of the hard bottom with sand veneer habitat.

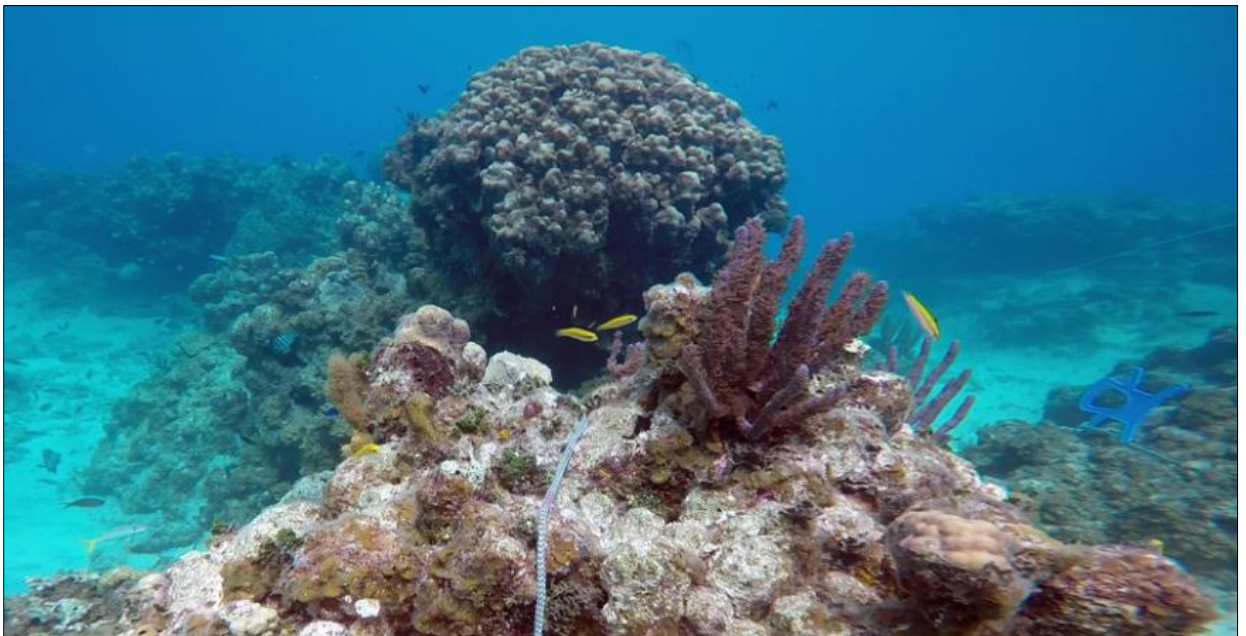
Exposed reef formation habitat (shown in yellow dots in **Figure 6**) had irregular and relatively high topographic relief that supported a productive epibenthic community with 22 observed hard coral taxa (**Image 11**). Coral densities for the exposed reef formation habitat ranged from 7.6 to 15.2 colonies m<sup>-2</sup> of hard corals and from 0.1 to 5.3 colonies m<sup>-2</sup> of soft corals. Although the exposed reef formation habitat was dominated by smaller corals, with 34.2% of hard corals greater than 10 cm and considerable populations of larger soft corals (>25 cm in height) suitable for translocation, the coral community characteristics of this habitat would facilitate efficient and productive coral translocation efforts.

Image 11. Representative image of the exposed reef formation habitat.

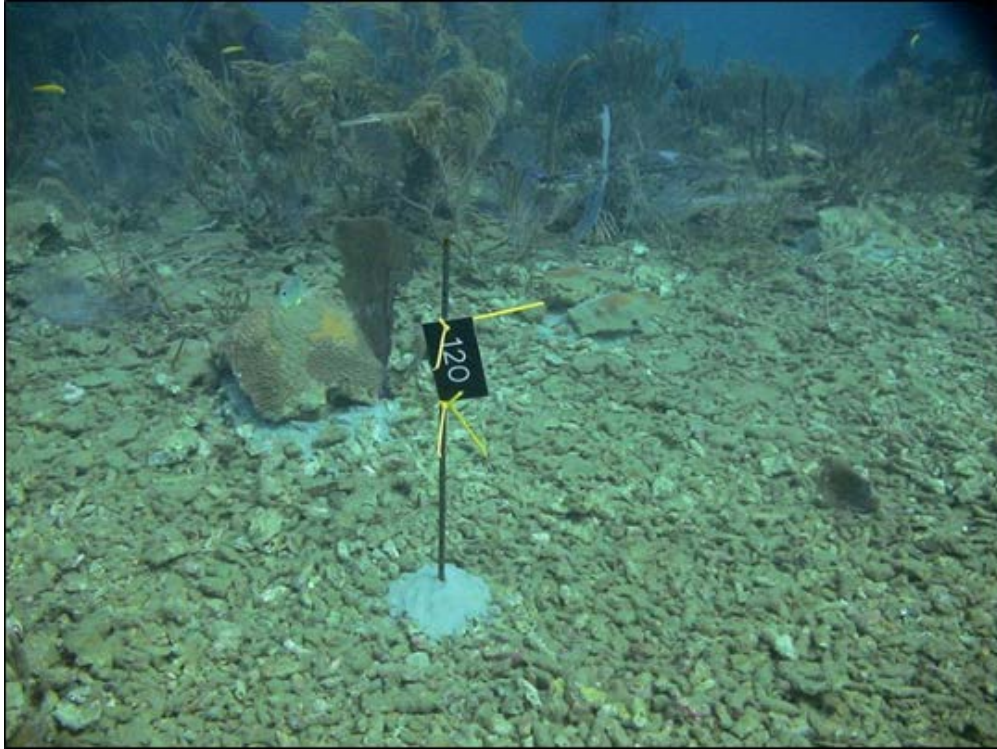
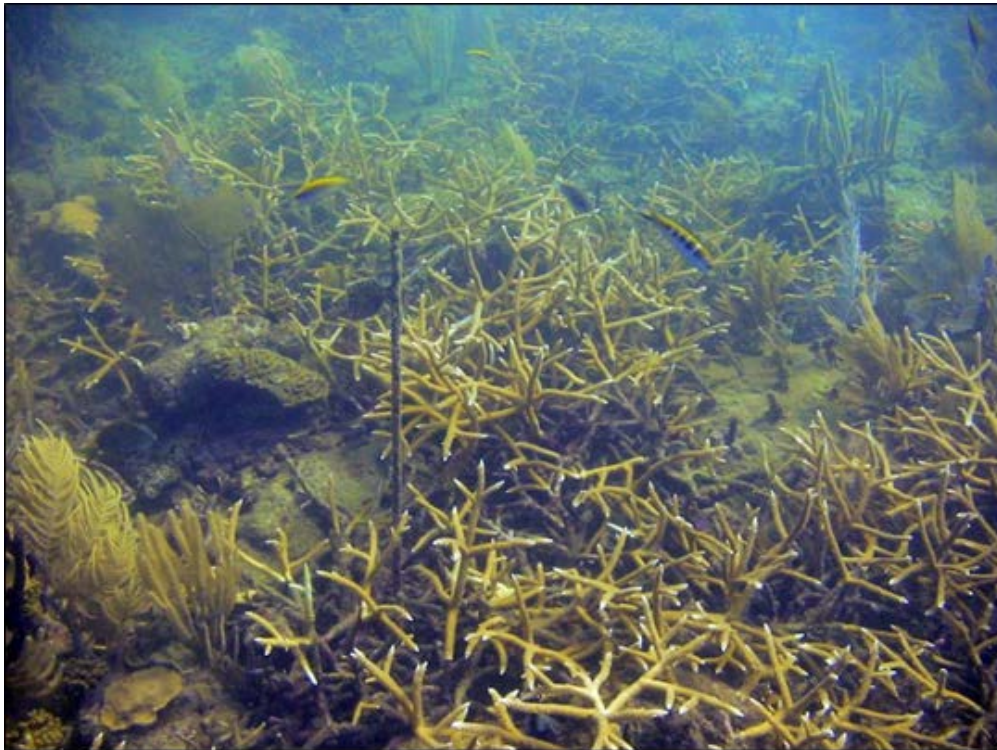
Image 12. Successful reattachment of staghorn coral (*Acropora cervicornis*), which is listed as Critically Endangered in the International Union for Conservation of Nature Red List of Threatened Species. Location of vessel grounding shown denuded of coral assemblage (a) and site shown approximately 6 years after reattachment of coral and other biota (b).

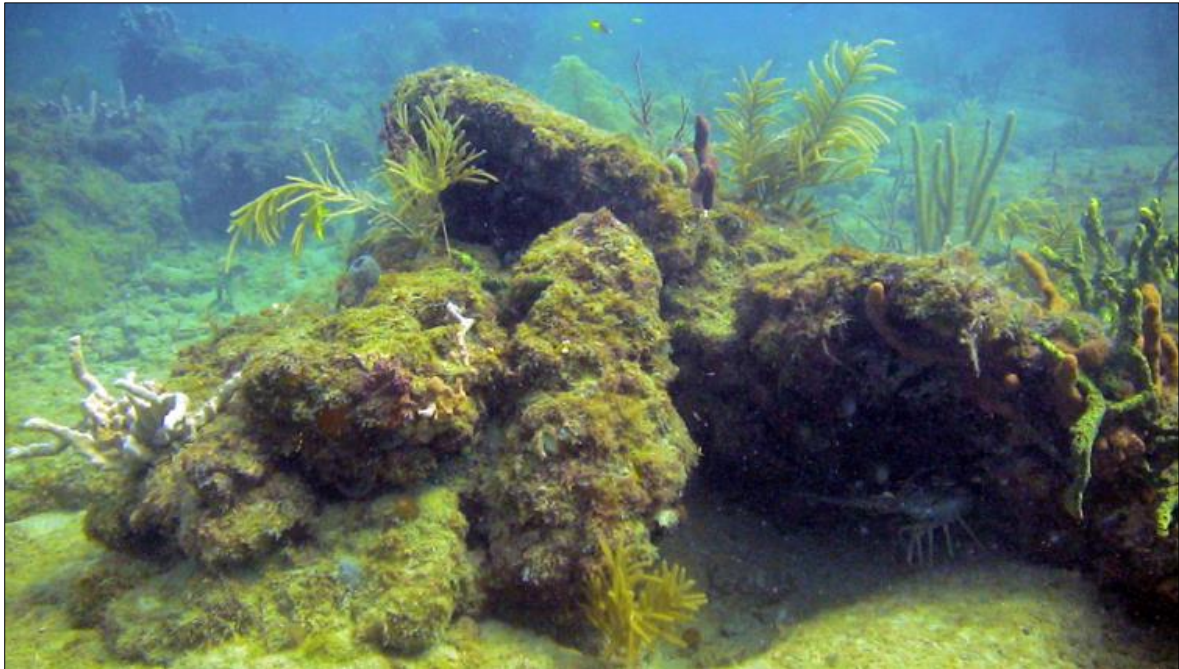
Image 15. Stabilized substrate at a vessel grounding site was used to restore structural complexity of an impacted habitat and/or to mitigate for loss of exposed hard substrate.

The objective of substrate augmentation is to establish hard substrate features to provide refuge for mobile fauna and suitable habitat for natural recruitment or translocation of epibenthos. Substrate augmentation can be used to restore structural complexity of an impacted habitat and/or to mitigate for loss of exposed hard substrate associated with a project activity, such as the berthing project (**Image 15**). Augmentation increases substrate surface area and availability for epibenthic settlement; surface area and abundance of sessile macroinvertebrates are variables which influence the diversity and abundance of fishes (Ferreira et. al., 2001). Other factors that influence the number of reef fish species and their abundance is substrate and habitat complexity in the form of vertical relief and number of interstices (Luckhurst and Luckhurst, 1978; Dennis and Bright, 1988), which can be considerably enhanced by proper substrate augmentation programs.

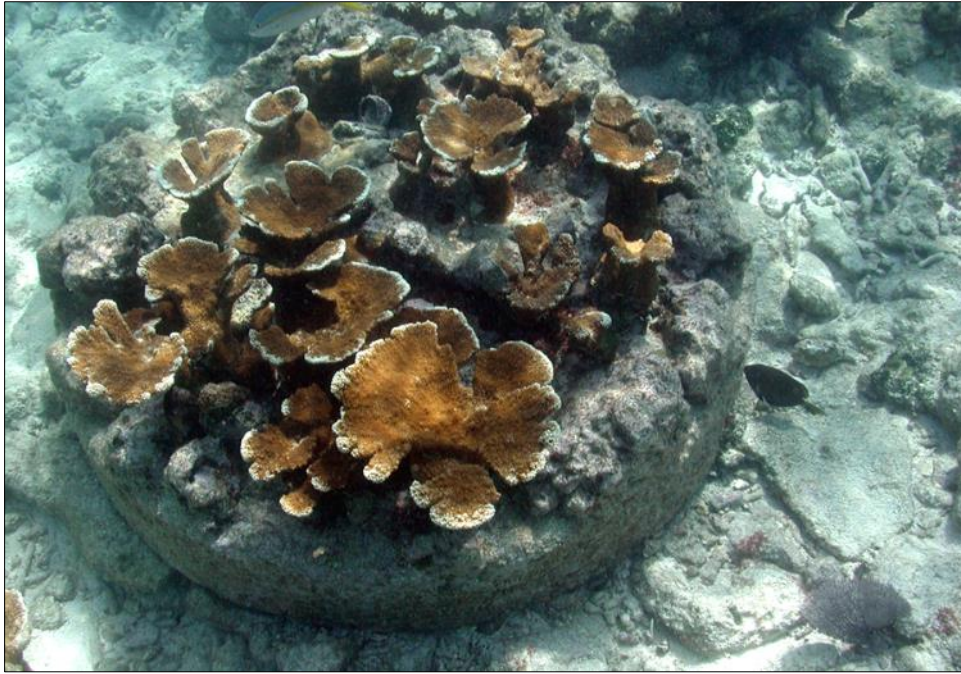
Image 16. Successful reattachment of elkhorn coral (*Acropora palmata*), which is listed as Critically Endangered on the International Union for Conservation of Nature Red List of Threatened Species. Coral fragments were reattached within a pre-fabricated reef module using cement. This restoration program was monitored by U.S. National Oceanographic and Atmospheric Administration (Schittone et. al., 2006).

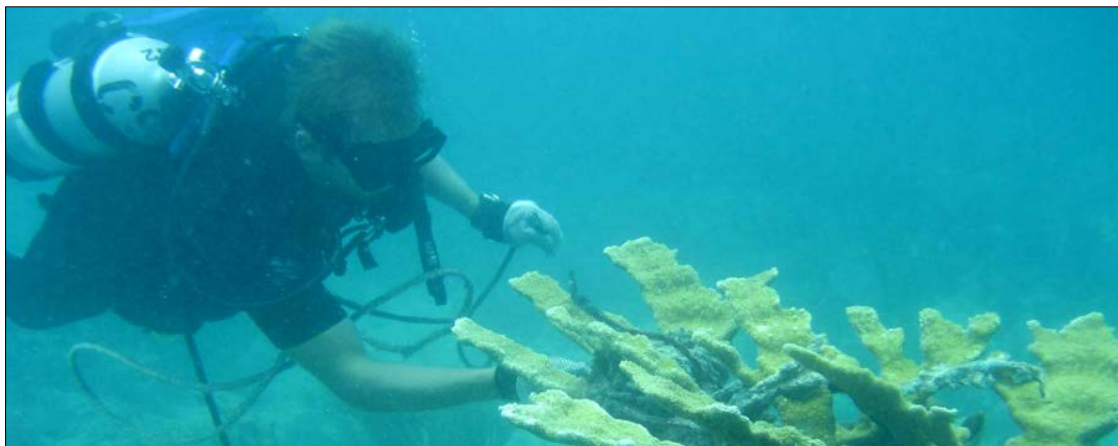
Image 17. Debris removal should be conducted in a manner to prevent collateral injury to reef resources.

The objective of debris removal from the reef habitats is to reduce the threat of damage to natural resources from persistence and dispersal of abandoned debris on reefs. The most prevalent debris are the metal-mesh fish traps, buoy lines, and monofilament fishing lines. The overall process for debris removal will include diver visual observations, document debris location, and physical removal. All work should be conducted with the utmost care in preventing collateral injury to the reef resources during the debris removal process (**Image 17**).
