INCIDENT INVESTIGATION REPORT

Fuel Tank Product Release ◀

**TapRoot® Investigation – Rubis Cayman Islands Limited, Jackson Point Terminal Fuel Release
from Tank No. 32198**

Grand Cayman, Cayman Islands

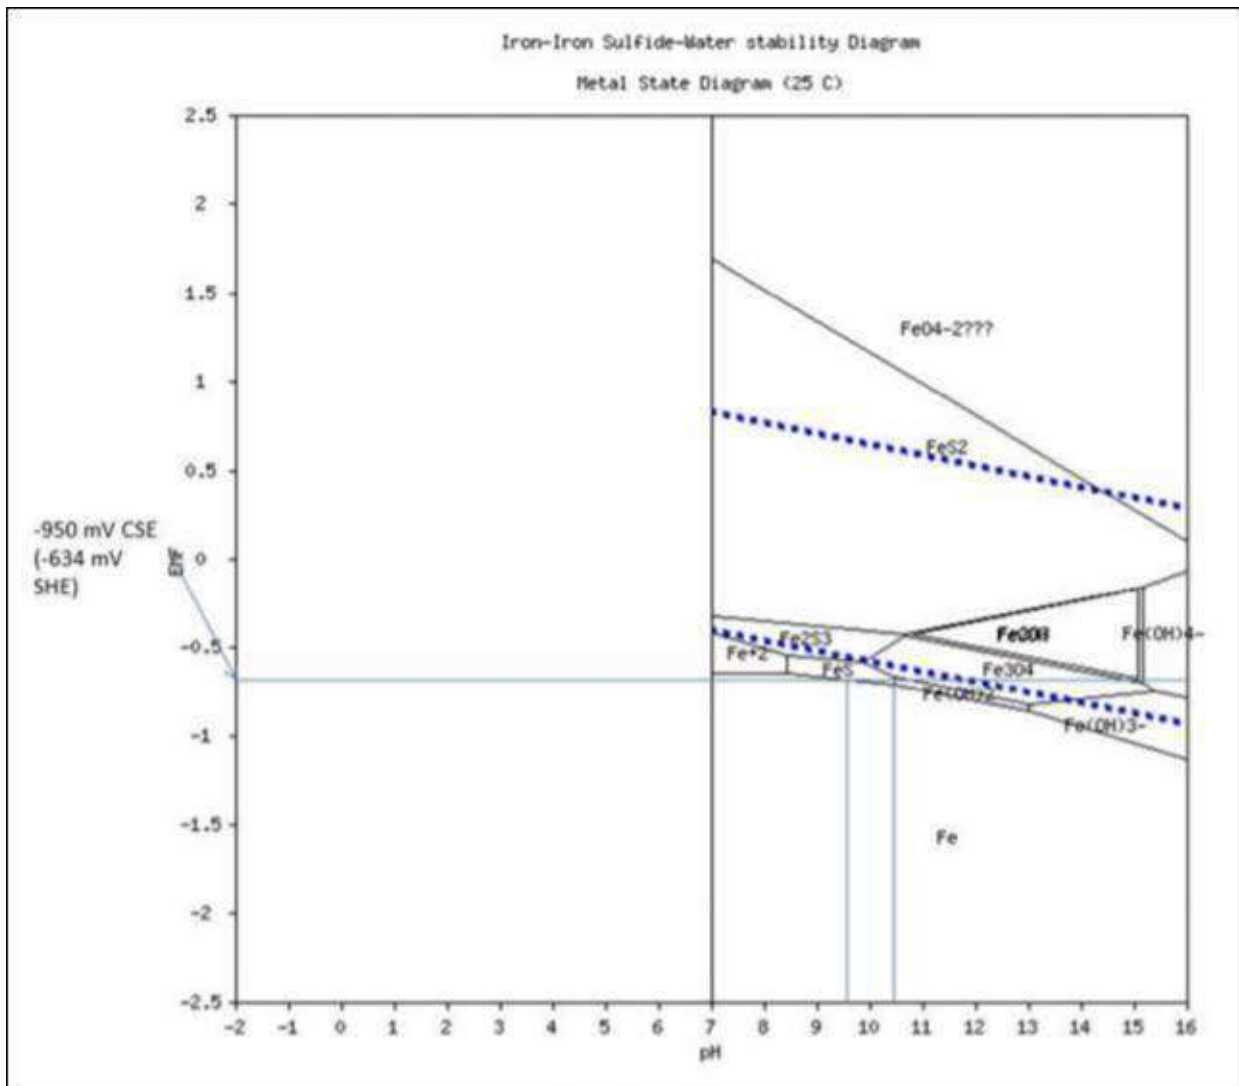
One of the main factors in corrosion acceleration owing to MIC is the formation of the iron sulfide. The cathodic potential of -950 mV_{CSE} recommended for cathodic protection under risk of MIC appeared to have effect of reducing the probability of deposition of iron sulfide, so *minimum NACE CP -950 mV_{CSE} criteria* is considered in the presence of anaerobic conditions. Note the below Iron-Iron Sulfide-Water Stability Diagram:

- From the above Iron-iron sulfide-water stability diagram, stability regions for iron sulfide (FeS), ferric sulfide (Fe_2S_3), and pyrite (FeS_2) can be seen.
- As can be seen, above the potential -950 mV_{CSE} , a wide range of sulfide compounds are stable.
- It can be observed that at potential -950 mV_{CSE} and below, iron sulfide is marginally stable at a small pH range of around 9.5 to 10.5. Below this potential, no sulfide compound is stable.
- Thus, cathodic polarization below -950 mV_{CSE} has the effect imposing an environment where iron sulfides are not thermodynamically stable.

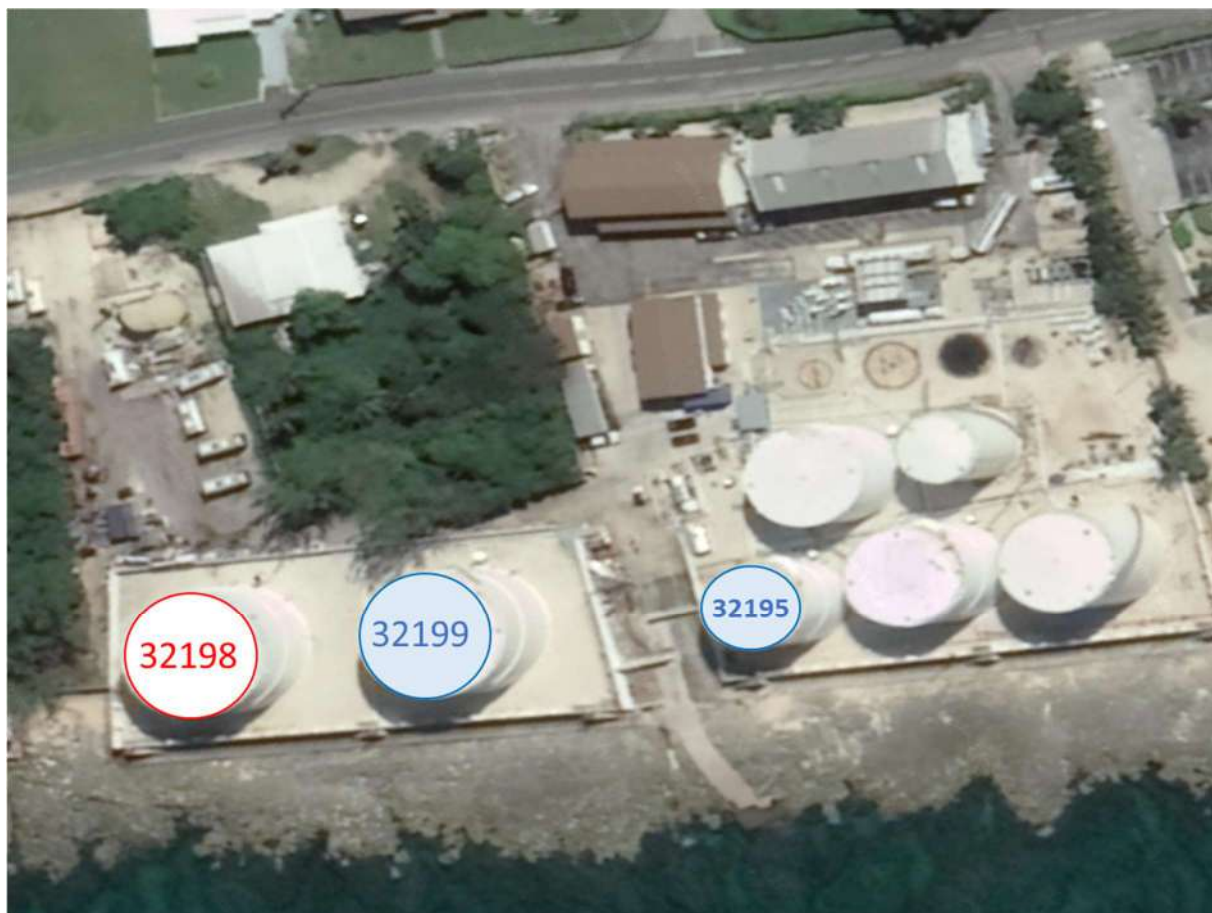
RCIL Jackson Point Terminal

Tank # 32198 | Tank where leak was identified.

Tank # 32199 | Tank that received fuel via transfer from Tank # 32198 during response efforts.
